# TOTAL CORROSION MANAGEMENT

# Sika FerroGard® 903

## CASE STUDY

Maverick Beach Resort, Ormond Beach, Florida

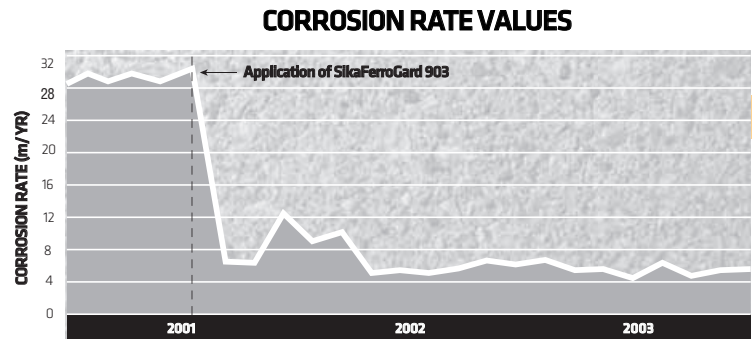
**TEST DATE**  
Monitoring and data provided by C-Probe Technologies Ltd.  
(MAVERICK BEACH RESORT)

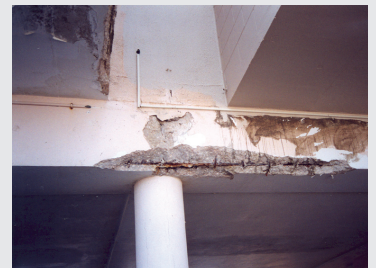
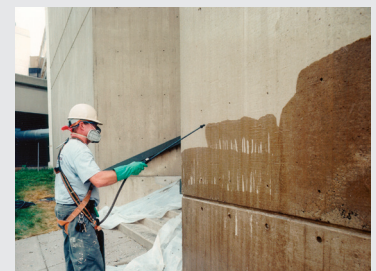
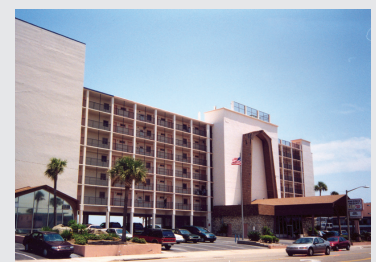
Delaminated concrete primarily along the edges of the elevated walkways and the columns was removed and repaired. Sika MonoTop 611, a one-component, polymer-modified, silica fume enhanced pumpable, pourable repair mortar was used along the walkways and SikaTop 123, a two-component, polymer-modified, non sag mortar containing Sika FerroGard was used for the column repairs. Achilles IES remote monitoring probes provided by C-Probe Technologies were installed to monitor the performance of the repair system. Sika FerroGard 903, a surface-applied, penetrating corrosion inhibitor was applied, primarily, to mitigate active corrosion in the unrepaired, chloride-contaminated areas of otherwise sound concrete. A waterproofing coating was also applied to prevent future ingress of moisture and chlorides and to prevent the steel's environment from getting increasingly worse.

The Maverick Beach Resort, built in the early 1970's, is a seven story, cast-in-place, conventionally reinforced concrete structure with a masonry façade located on the beach.

The balconies had been removed and replaced in 1987. This large building; however, continued to suffer from corrosion accelerated by chlorides. The source of the chlorides was salt spray from the sea water.
