Market	Bridge
Application	Concrete Repair and Strengthening
Focus	Chloride Induced Corrosion

Project: Hopkins & Clinton Street Bridge Rehabilitation
 Owner: Defiance, OH
 Specifier: Foster Engineering, Inc.
 Contractor: Structural Preservation Systems
 Year: 2003

Case Study

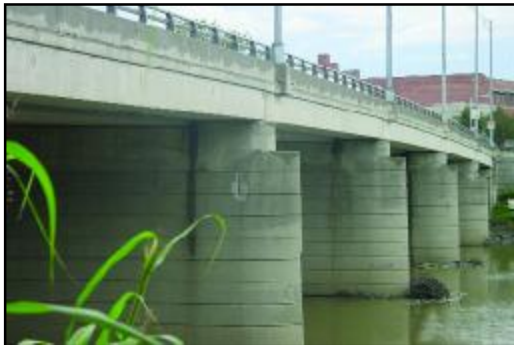
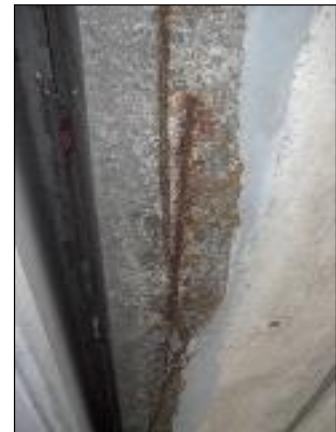
The Hopkins and Clinton Street Bridges were suffering from significant corrosion damage brought on by the extensive use of de-icing salts in northern Ohio. An improperly designed drainage system allowed storm water to flow over the roadway and through a gap between the road and sidewalk. The storm water picked up all deleterious materials, especially de-icing salts, and deposited them onto the exposed side of the fascia box beams.

After nearly 25 years of exposure, the chlorides were able to penetrate the concrete to the depth of the strands in these precast, prestressed box beam structures. The corrosion caused the steel to expand, causing extensive cracking, spalling and delamination of the concrete. Approximately 25% of the tendons were either damaged or lost due to the corrosion on the bridge.

Before the two bridges could be structurally strengthened, an extensive concrete repair and waterproofing program was undertaken. The areas that required the most concrete repair were the face of the abutments and the sides and the bottom of the fascia beams. Sika Armatec 110 EpoCem was used as an anti-corrosion coating and bonding agent. SikaTop 111 and 123 were used to repair the damaged concrete. Sikadur AnchorFix-3 was used to dowel in some anchors on the bridge as well.
