TOTAL CORROSION MANAGEMENT

Sika FerroGard® 908

Mazza Galerie, NW Washington DC

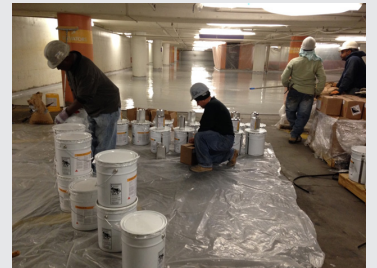
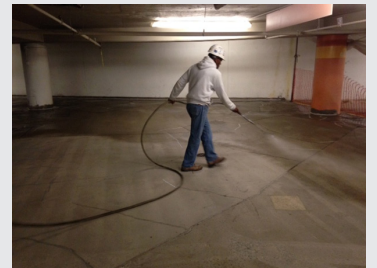
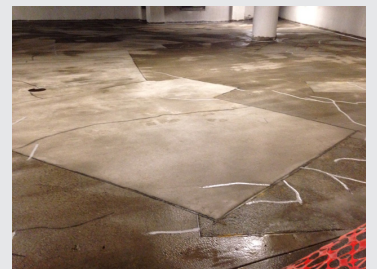
The interior garage decks beneath the popular Mazza Gallerie have been exposed to many years of water and deicing salts carried in with the busy traffic frequenting the retail stores. Severe corrosion of the cast-in-place concrete reinforcement developed causing cracking and spalling of the concrete. This damage was concerning to the health of the structure and unappealing to the patrons.

Areas of spalled and delaminated concrete were completely removed and replaced with full depth ready mix concrete. The entire area was shotblasted to prepare the surface. Sika FerroGard 908, a dual-functional corrosion inhibitor was then sprayed to penetrate the concrete particularly to treat the areas undergoing latent corrosion where the steel reinforcement was in an elevated concentration of chlorides. Next all the joints and cracks were sealed with Sikaflex 2c NS EZ Mix, a polyurethane-based, elastomeric sealant. To complete the protection and create a seamless, bright, and attractive appearance, the Sikalastic 720/745 AL Gray traffic bearing membrane was installed. This coating system will stop further entry of water and deleterious elements while enduring the pedestrian and vehicular traffic. To ensure the quality of the repair and protection strategy, corrosion rate monitoring is performed by a corrosion consultant. It is expected that corrosion rates will remain passive.
